Enhanced Preliminary Assessment Report:

Irwin Army Housing Units
Irwin, Pennsylvania

October 1989

Environmental Research Division
Argonne National Laboratory
Argonne, Illinois 60439

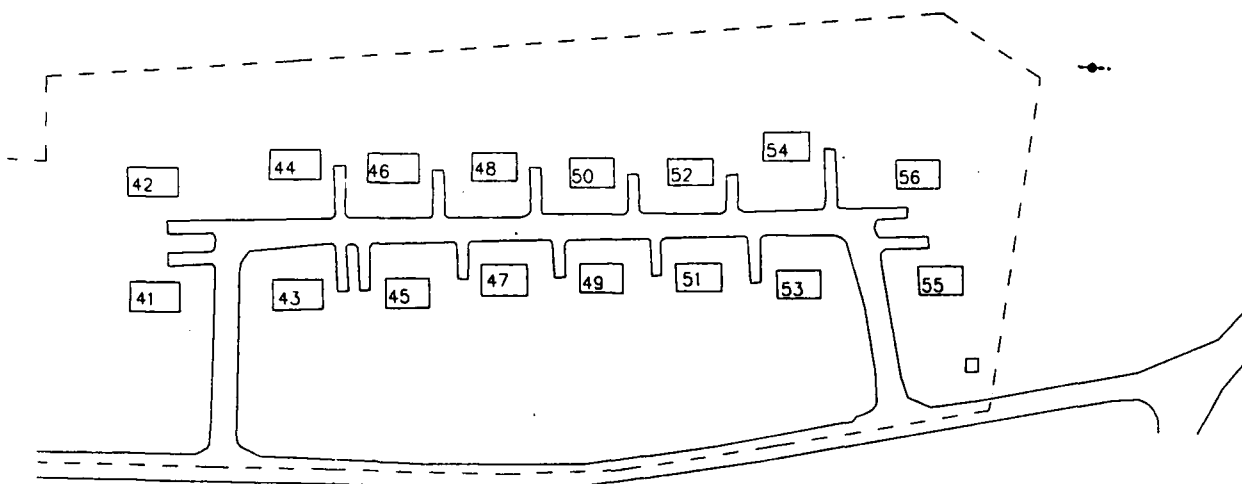
FIGURE 3 Site Plan Map of Irwin Army Housing Units

Figure 3 presents the site plan of the housing area.

shake siding. The roofs consist of asphalt shingles. Each unit has an exterior storage building, two garbage receptacles (no longer in use), and a paved terrace. All 16 units have three bedrooms. Five units each contain 1,287 square feet. The other 11 units each contain 1,171 square feet.³ The houses are heated separately with natural gas and forced-air systems.

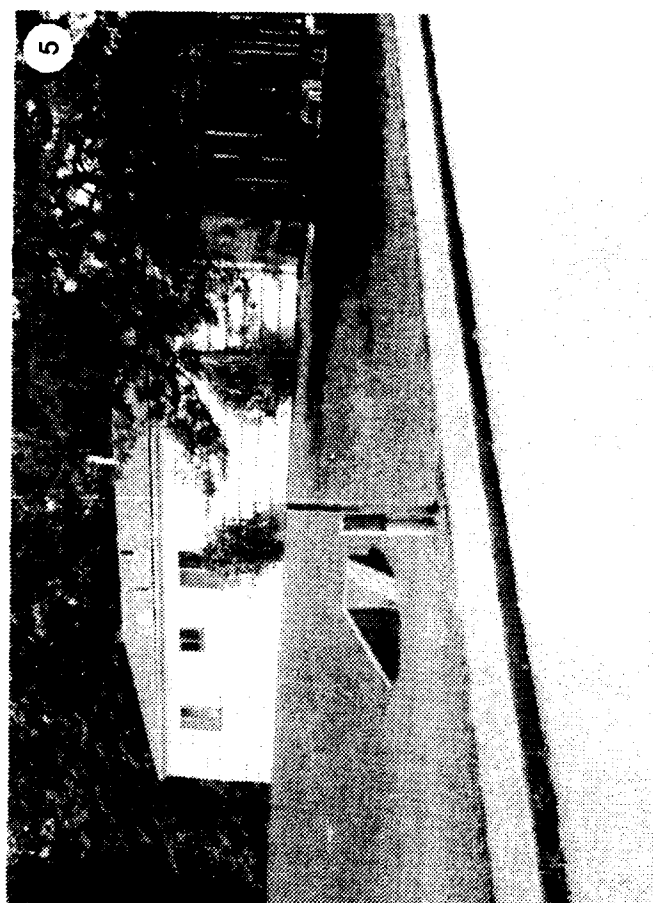
Building siding is asbestos shake; asphalt tile floors inside the units may also contain asbestos. A pole-mounted transformer that services the site has not been tested for the presence of PCBs; however, the transformer is the property of the utility. No evidence of spills or leaks from this transformer was identified.

1. A view of the housing area.
2. Grounds at the rear of the housing units.
3. Playground at the housing area.
4. Electrical transformer mounted near the top of the utility pole; the transformers are the responsibility of the Plainville Power Company.
5. A side view of a housing unit; in the foreground are a gas pipeline marker and a storm drain; the housing area uses natural gas for fuel, thus requiring no oil-storage tanks.
6. The opening of a storm drain.
7. The sewage-treatment system, with separators located behind the fenced gate.
8. The trickle rock-bed of the sewage-treatment system.
